PROJECT INTRODUCTION AND WAIVER ELIGIBILITY

Johnson, Mirmiran & Thompson (JMT) is working with Island Roads Construction (IRC) as a Design/Build Team, under contract with the Federal Highway Administration, Eastern Federal Lands Highway Division (FHWA EFL) and working with the US Virgin Islands Department of Public Works (DPW), to repair damage caused by Tropical Storms/Hurricanes Irma and Maria. The Team will be completing design, permitting, and construction of repairs for 13 roadway sites on St. Thomas, 2 of which are anticipated to potentially impact the CZMA (**Table 1, Figures 1-3**). The project is not anticipated to expand the footprint of the roadway for the sites, although there may be some temporary disturbance outside the existing footprint for construction. At this time, additional right of way acquisition is not expected to be needed; however, some temporary or permanent construction easements will be needed at several sites to construct the repairs. The majority of the sites affected were impacted by landslides caused by storms.

JMT is applying on behalf of DPW and EFL for a waiver for impacts to the CZMA at two sites in St. Thomas based on the following 2019 US Vi

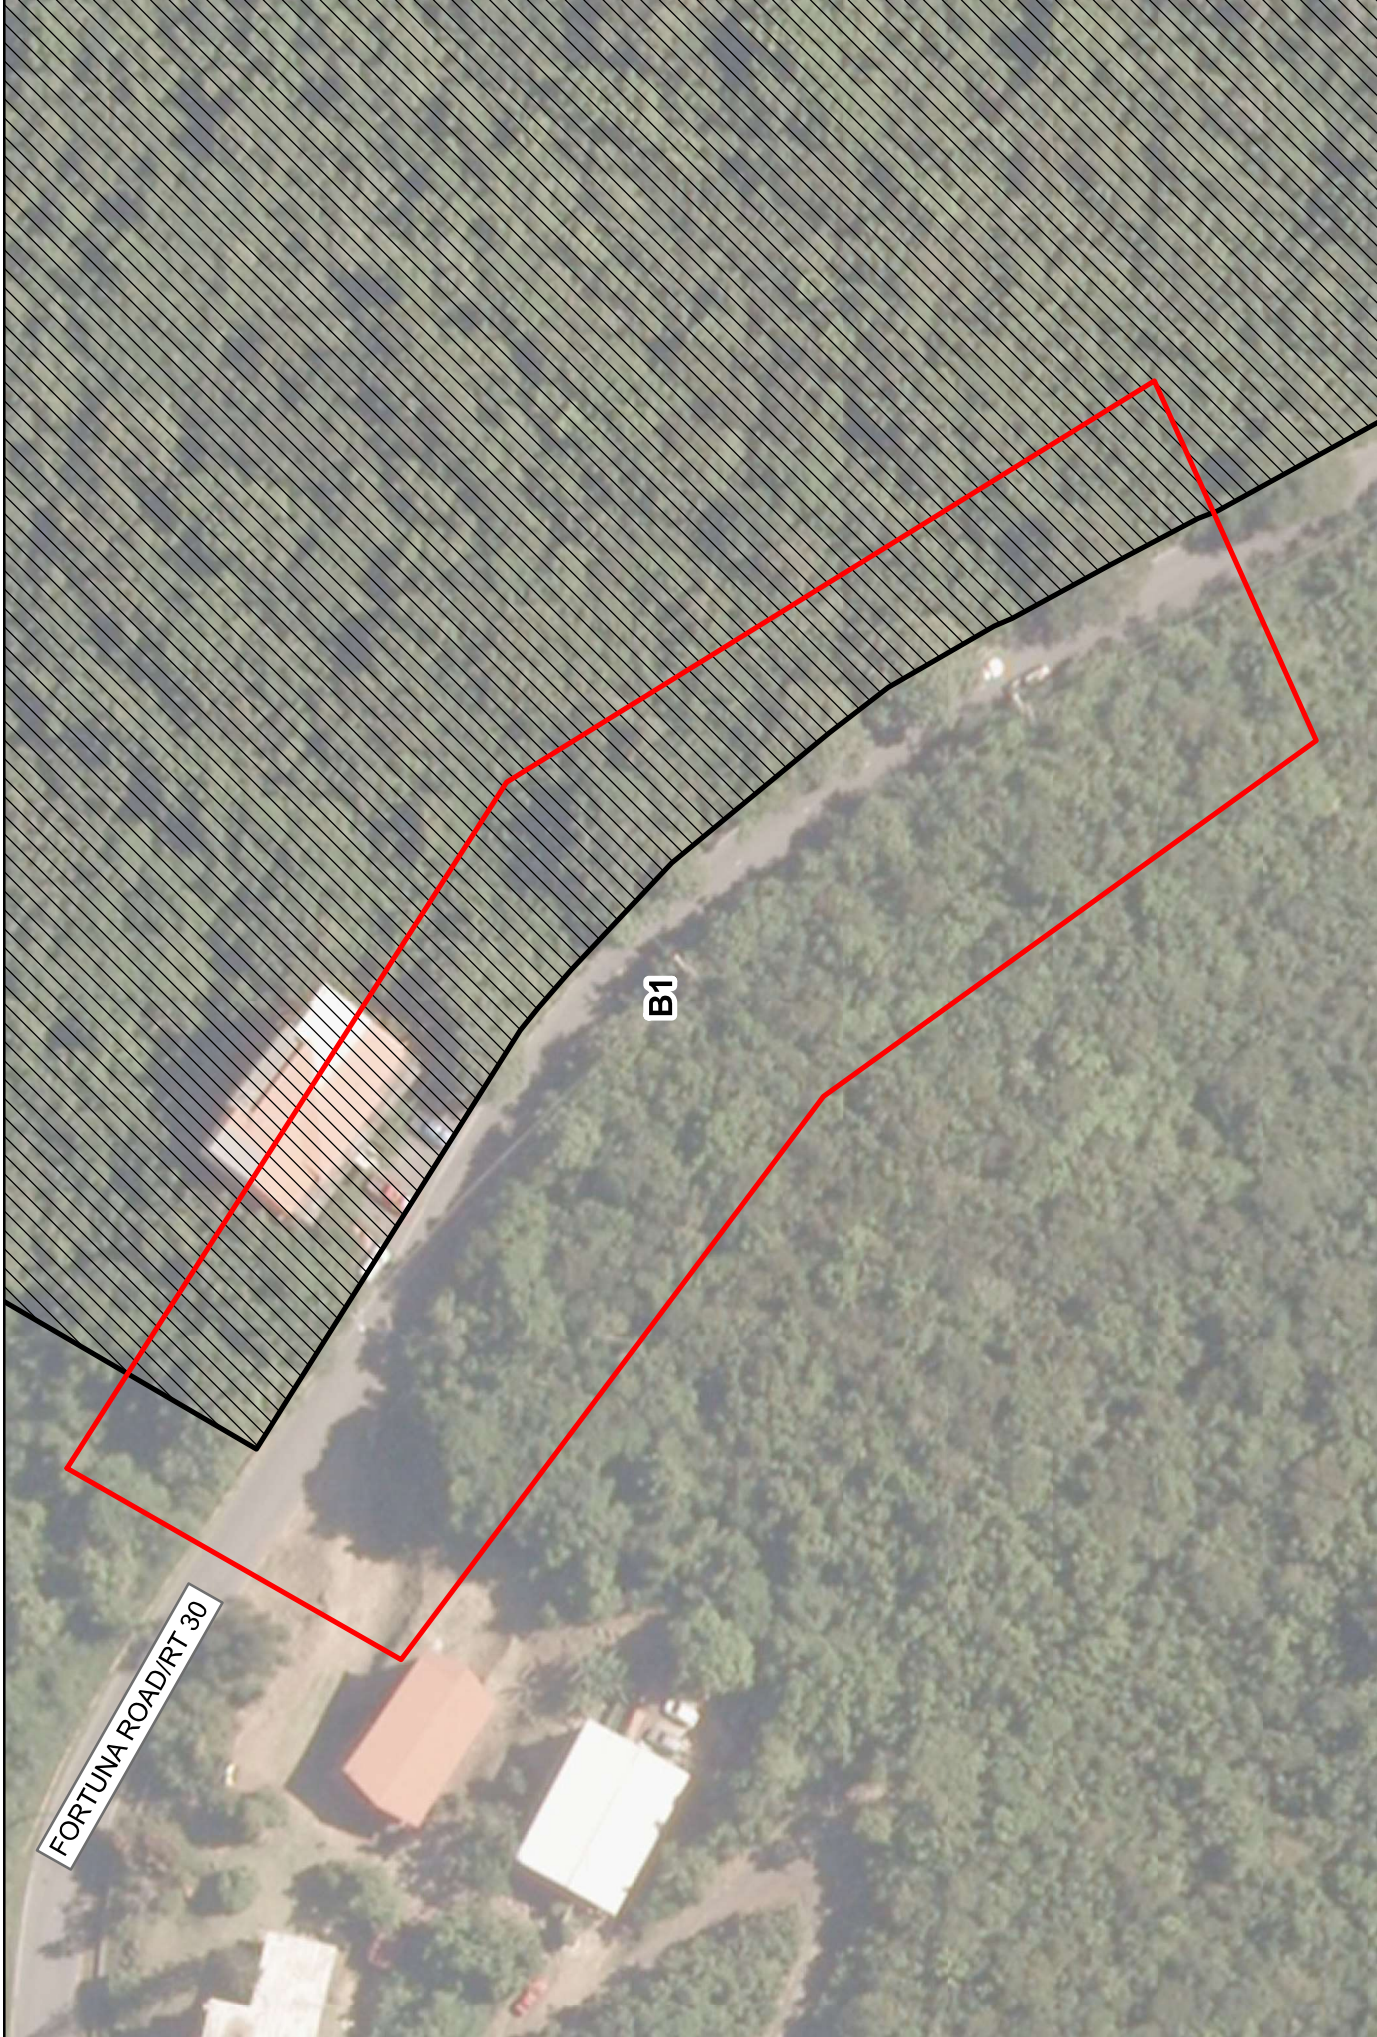
FIGURE 2: SITE B1
ST THOMAS; US VIRGIN ISLANDS
ROADWAY REPAIRS

Site B1 (Figure 2) was impacted by a landslide and slope failure. A detailed damage description is included in Appendix B. Minimal work is proposed including clearing and grubbing and seed and slope erosion control matting.

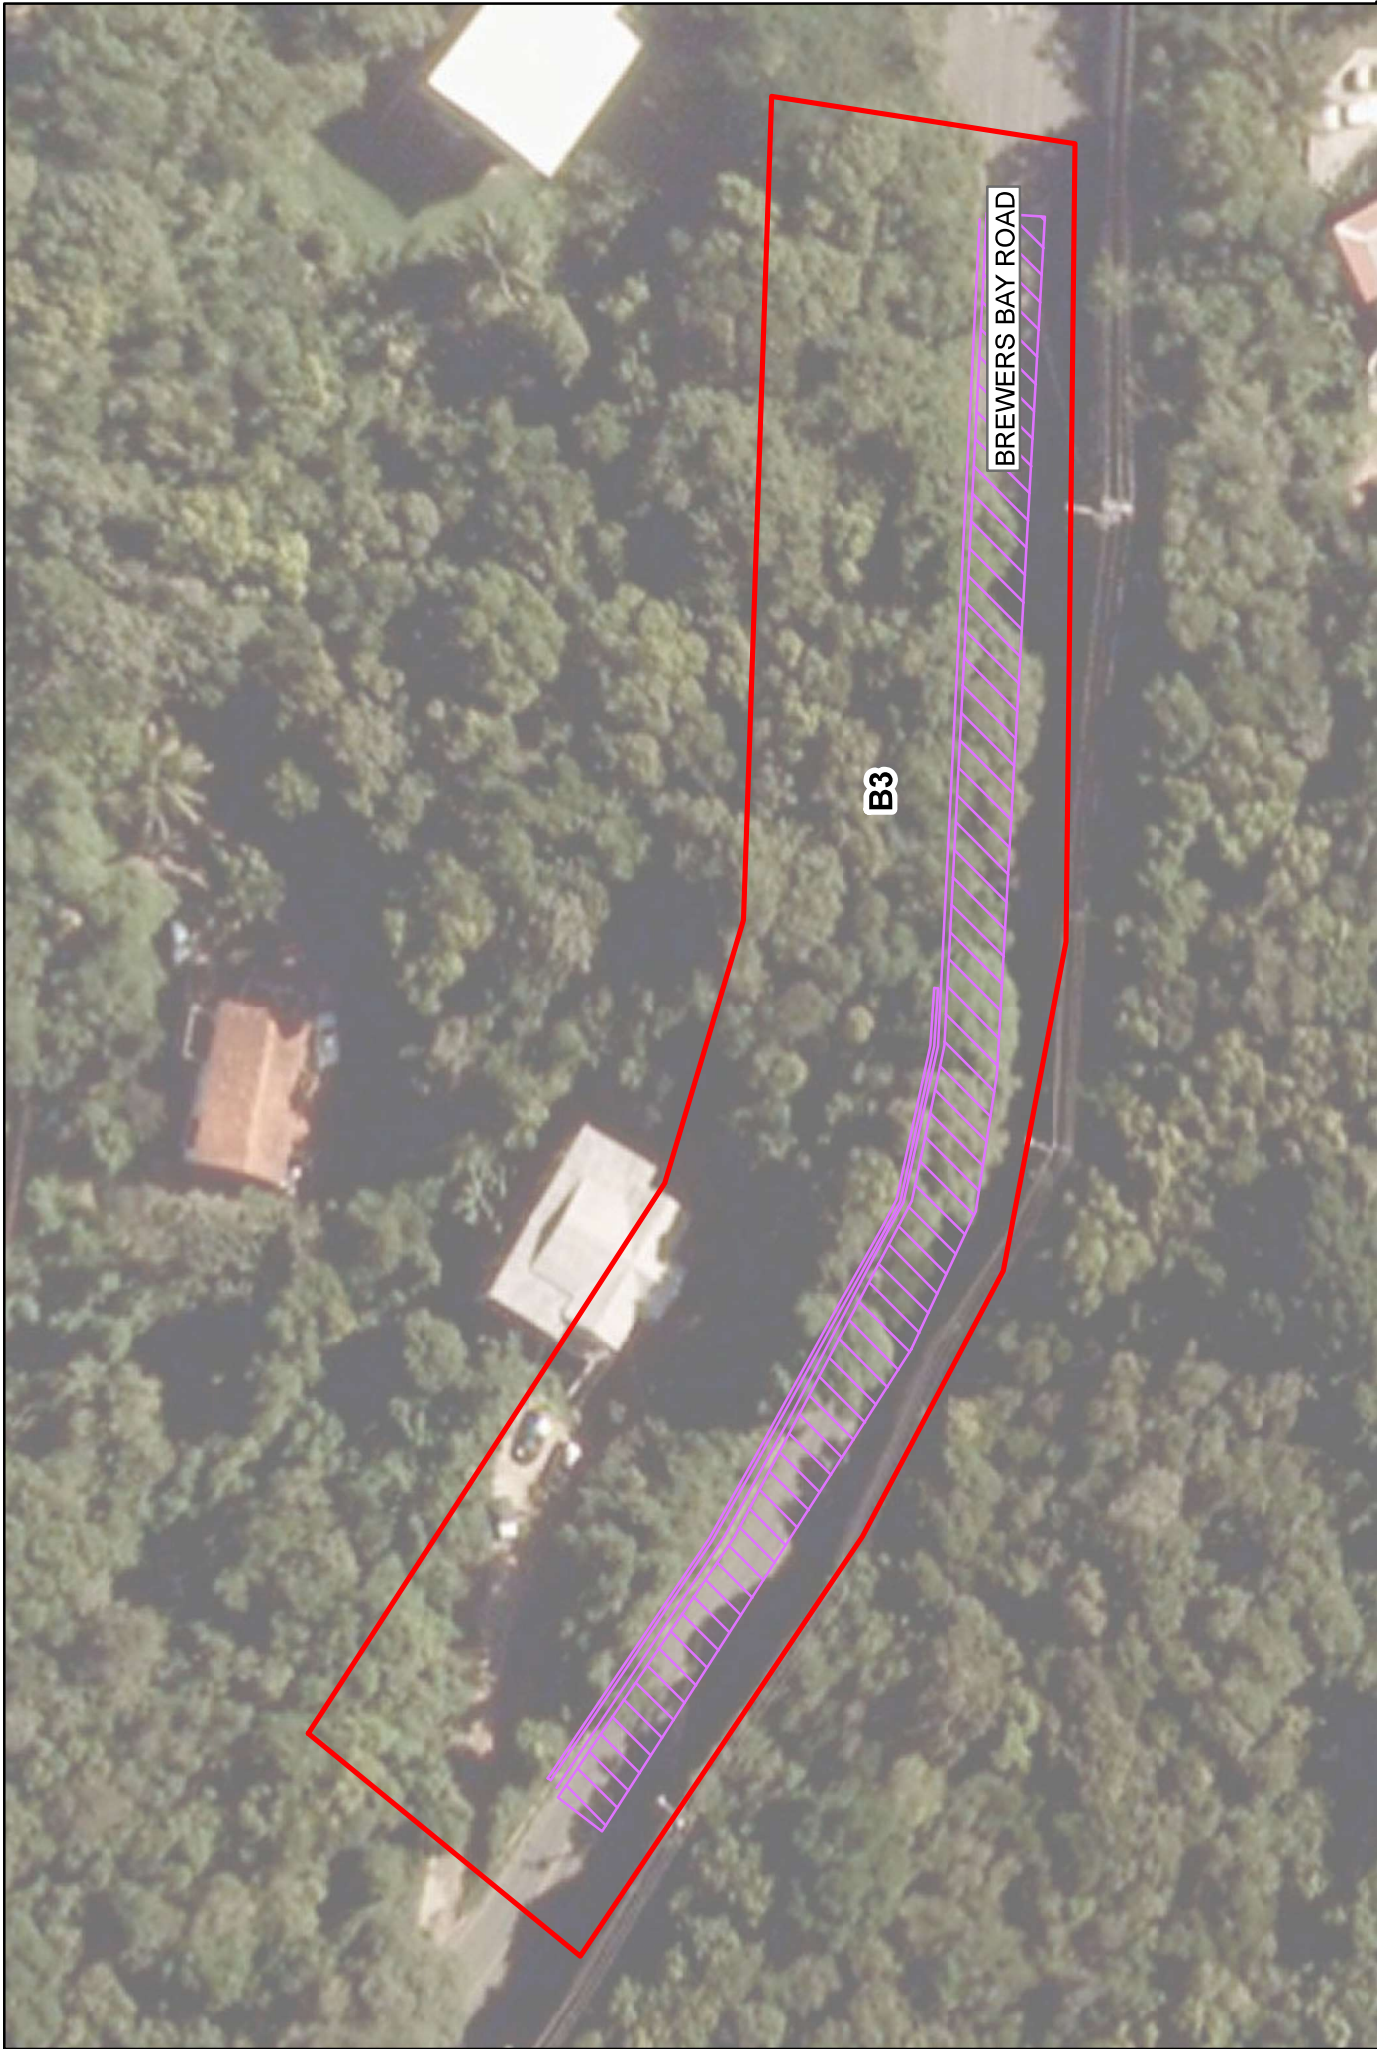
<p>FIGURE 3: SITE B3 ST THOMAS; US VIRGIN ISLANDS ROADWAY REPAIRS</p> <p>MARCH, 2021</p>
---	--	---	--

Site B2 (Figure 3) was impacted by extreme stormwater runoff during the hurricanes. A detailed damage description is included in Appendix B and detailed conceptual design plans can be found in Appendix C. The proposed work includes clearing and grubbing debris; removing and replacing guard rails and end terminals at multiple locations for a one-mile stretch; clearing drop inlets and culverts and replacing frames and grates.

Gabions will be used to stabilize the slope. Accessing the work area will likely require temporary impacts outside the current limits of pavement.

Appropriate erosion and sediment control measures will be applied based on approved standards and conditions set forth by agencies during the NEPA process, and as may be required by environmental permits. Work that is necessary outside of the established ROW footprint and paved area will be minimized as much as possible. Temporary impacts outside of the established footprint required to install the gabion wall needed to stabilize the slope will be minimized and done with the appropriate erosion and sediment controls.
